### Spring & Surface Water Inventory Form

Date & Time: 6/23/2017 Site Name/Site ID 153 N26 E53 31ADBB1  
Field Tech(s): Beau Parker / Sarah Overton Basin Name: Diamond Valley 153  
Owner: Ira R. & Montira Renner Elevation (ft): 6100  
MOU: STK Elevation Source (ie USGS topo): Topo  
County: Eureka  
Coordinates: 40.09451 N 116.03361 W (Decimal degrees)  
Legal Description: SE Qtr NE Qtr Sec 31 T. 26 N/S R. 53 E. Photo(s)  Yes  No

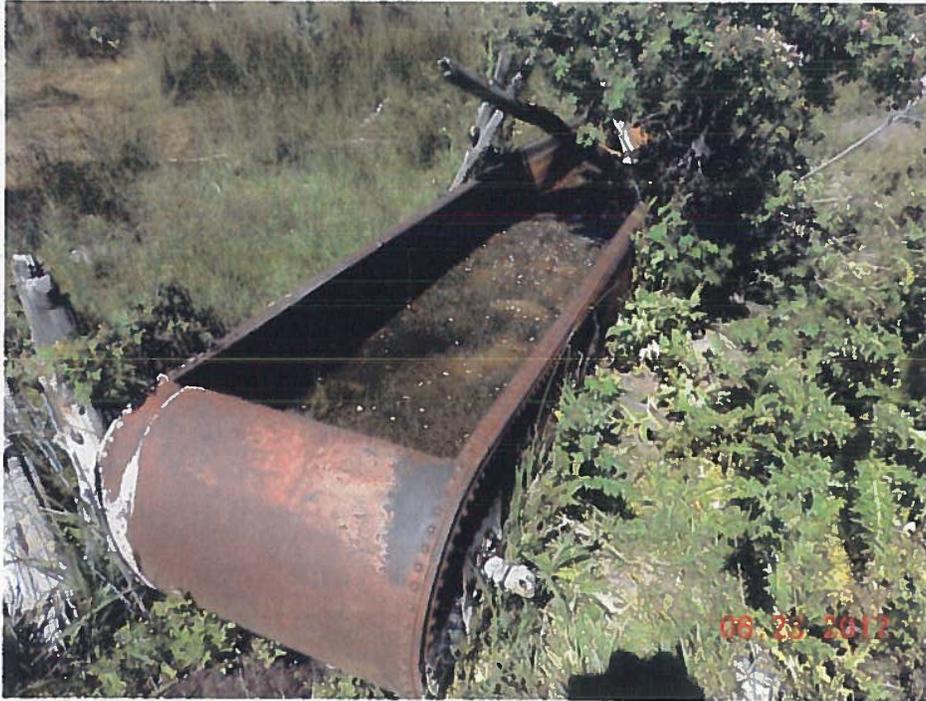
**GPS\_PHOTO\_WEEK\_2 581:** Trough is 48 feet below spring.

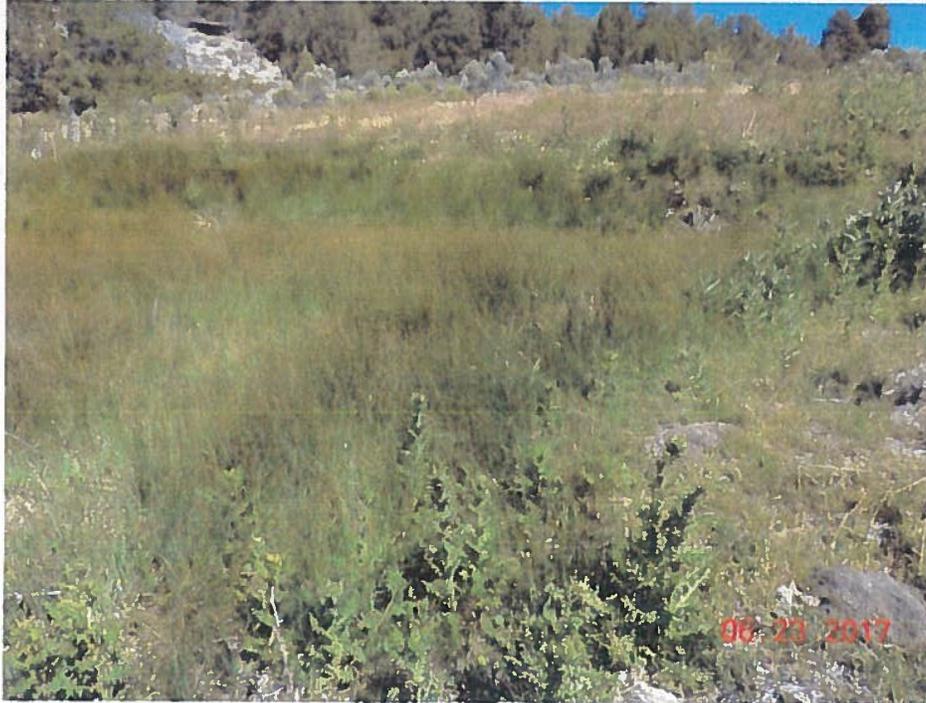
Small Natural cut in bank where water is discharged. Ground around discharge area is muddy. Thick grasses in spring area and thistle surrounding spring.

**GPS\_PHOTO\_WEEK\_2 588:** Large spring area. Water is being discharged from side of bank shown on the right side of the photo.
